Confidential Inspection Report

LOCATED AT:
Nowhere Rd.
Somewhere, BC

INSPECTED ON:
15 February, 2023

Inspector, Denis Lacroix 71731
Lacroix Home Inspection

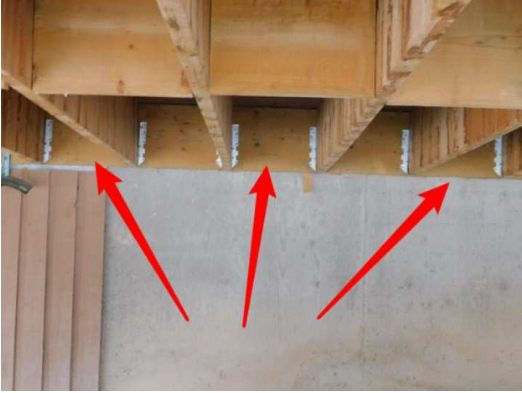
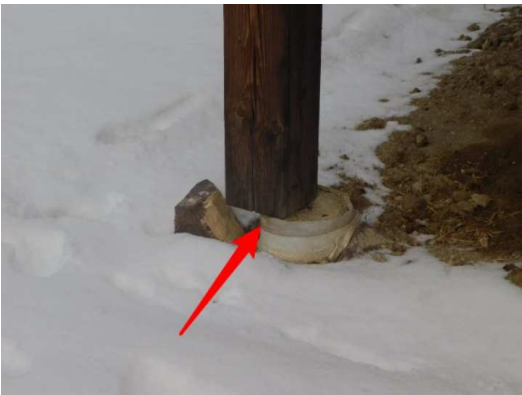
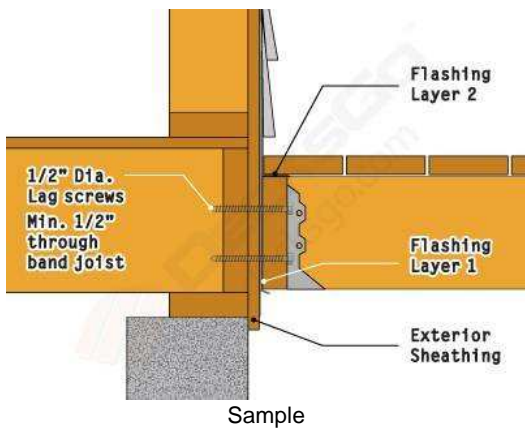
REP s-32: The decks appear to be properly constructed and generally in serviceable condition, with exceptions noted below.

- Ledger boards should be lag bolted to the house framing. (see sample)
- Post and concrete footings at the front deck are misaligned but should not be a structural concern.

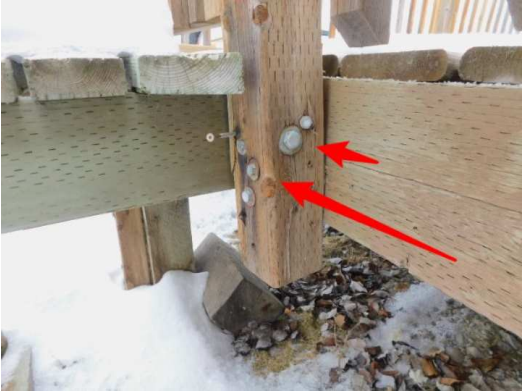
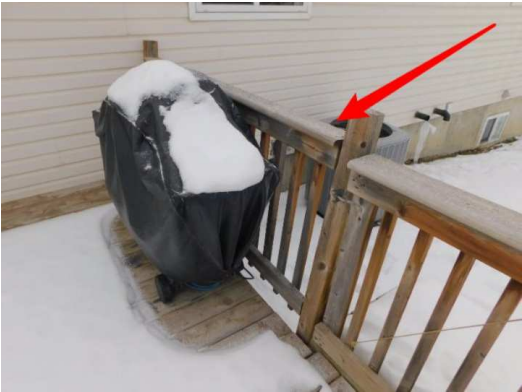
REP s-33: The railings at the back deck are not sturdy enough to resist a person's weight. One post is loose. We recommend that the railings be reinforced or replaced in accordance with present standards.

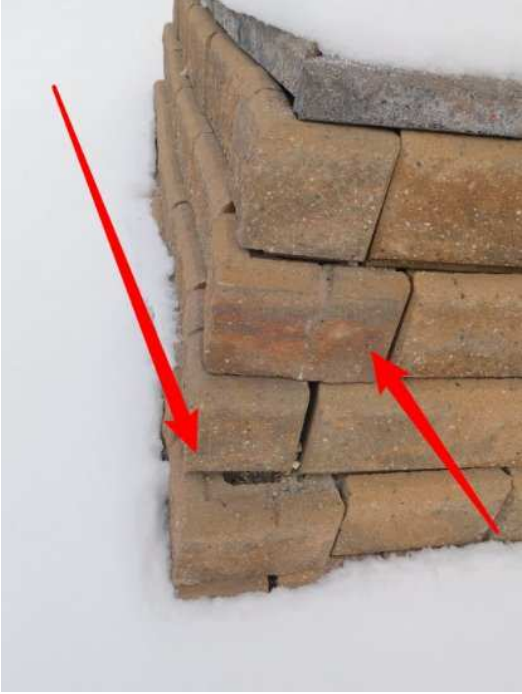
MON s-40: The structural retaining walls appear to have performed as intended and are generally in serviceable condition, with reportable conditions noted below.

- Small displacement of some of the blocks.

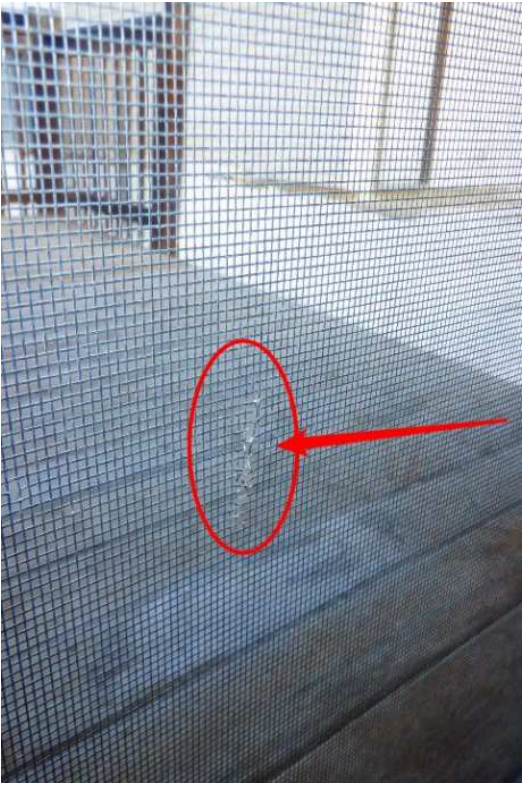
REP s-121: Caulking around the door frame is cracked and coming off. Recommend recaulking. Screen lightly damaged.

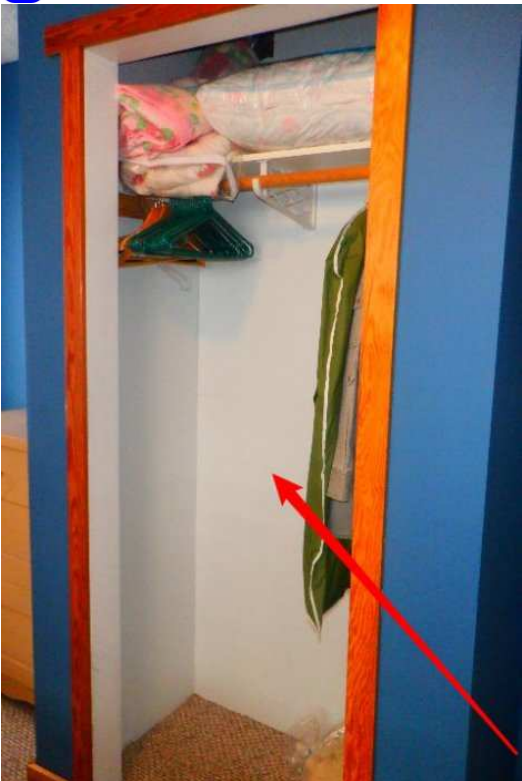
UPG s-150: Door missing.

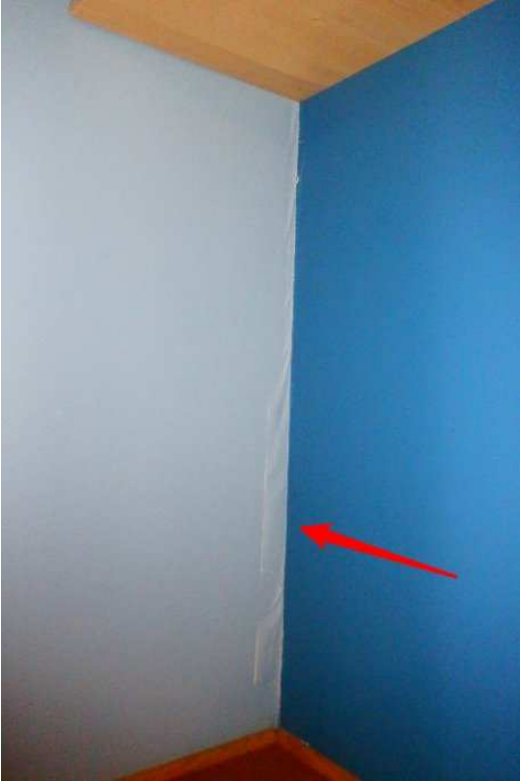
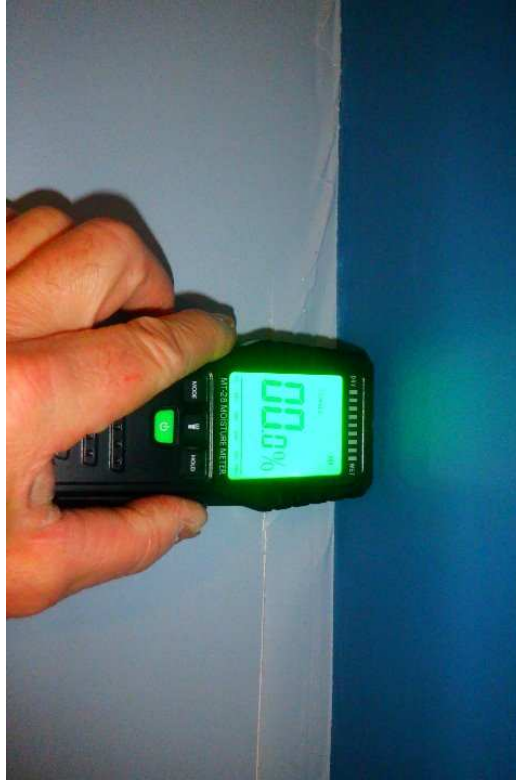
REP s-153: The tape on some of the drywall joints has separated. We recommend resurfacing and refinishing to restore appearance.

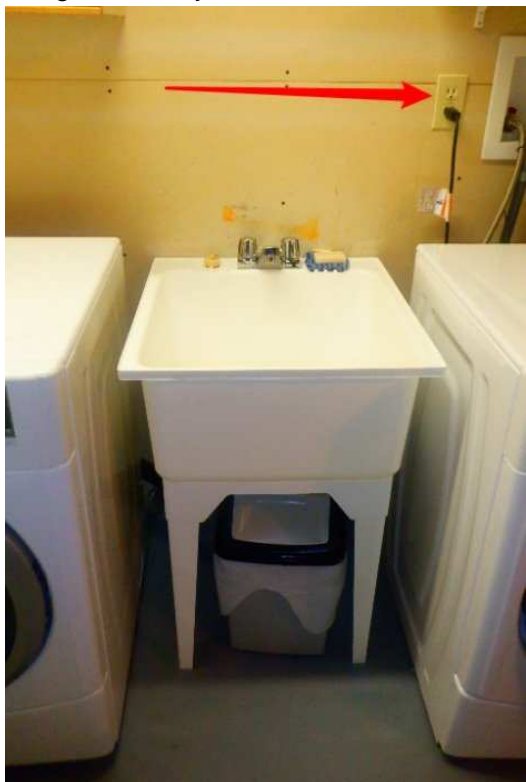
SAFT s-238: There is no GFCI (ground fault circuit interrupter) protection for this area. For an increased margin of safety, we recommend the installation of a GFCI receptacle.

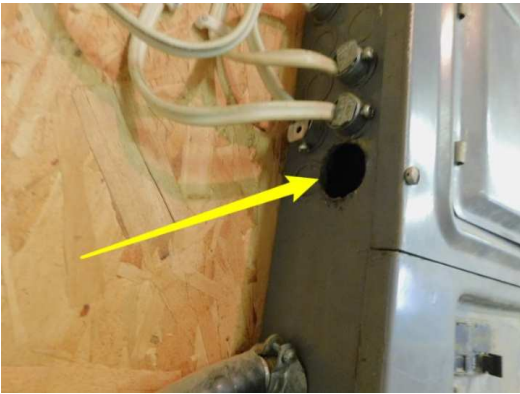
SAFT **REP** **s-272:** There are holes in the subpanel where 'knockouts' have been removed and left open. These holes may allow access to rodents that may chew the wires that may cause arcing and possible fire. This is not an approved practice and we recommend the holes be closed with approved filler plates.

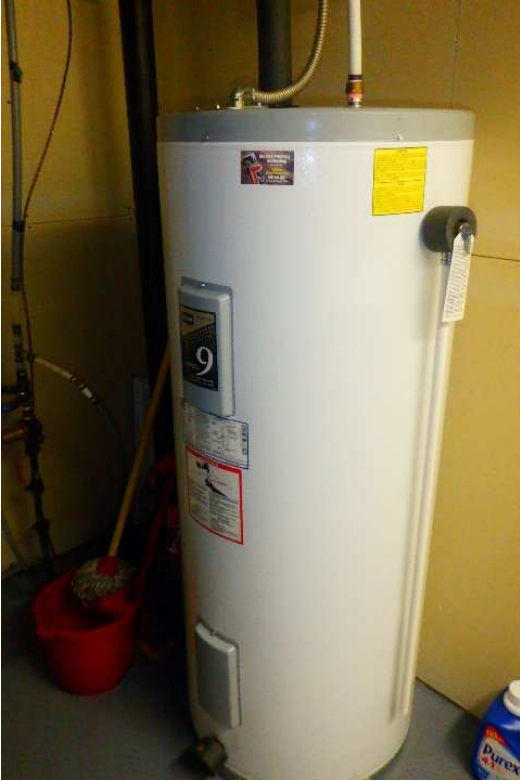
WARN s-308: This water heater is approaching the 12 year mark. Some insurance companies request water heaters be changed after 12 years. In addition, it is more likely to leak unexpectedly.

Recommend changing in the near future.

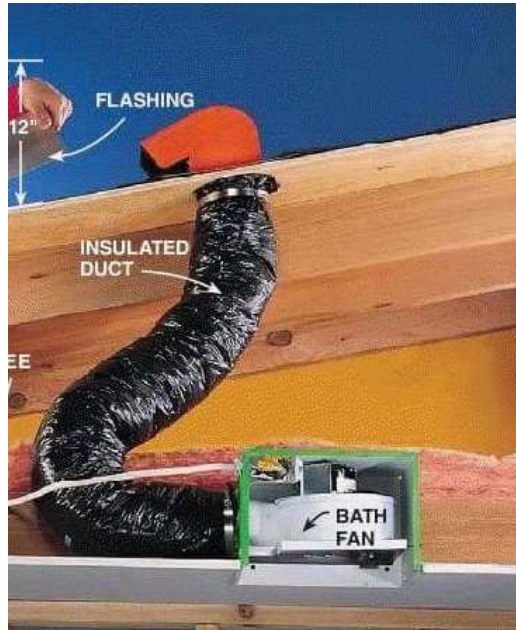
UPG s-381: Ducts are vented into the soffits which is causing some moisture to back draft into the attic. Recommend vent lines be directed through the roof into a proper roof hood.

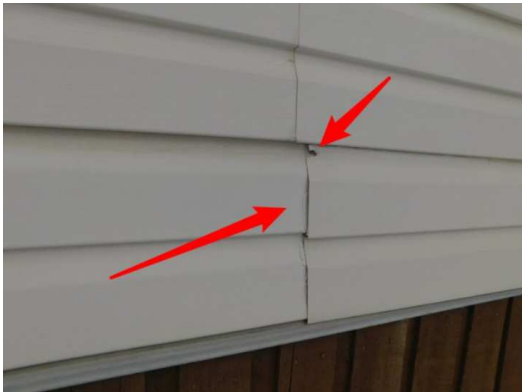
UPG 21: The vinyl siding appears to be properly installed and generally in serviceable condition, with exceptions noted below.

- A few small damaged areas were noted. Areas should be repaired to prevent water intrusion.

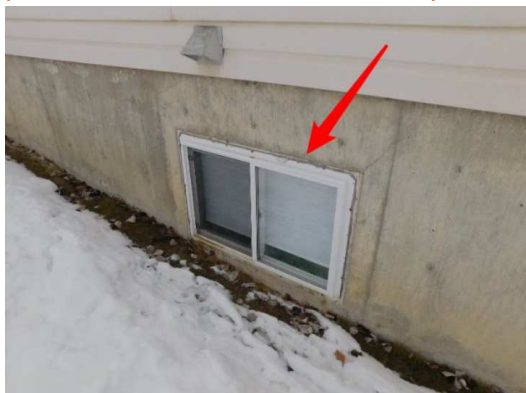
REP 25: No flashing has been installed at the back basement window, as would be considered standard practice. We recommend an acceptable metal flashing be installed to prevent leakage.

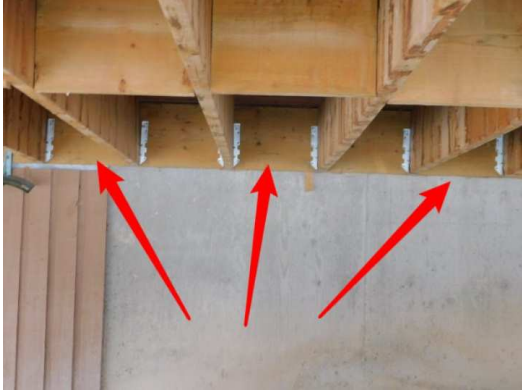
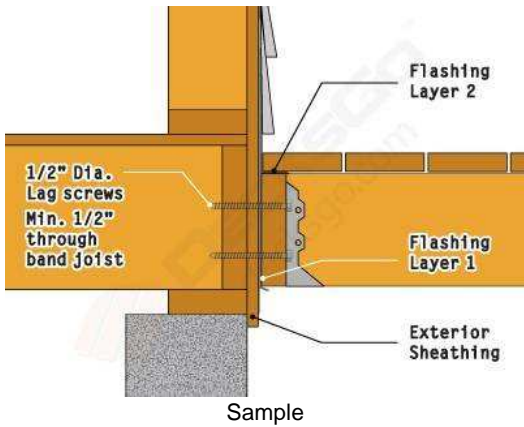
REP 32: The decks appear to be properly constructed and generally in serviceable condition, with exceptions noted below.

- Ledger boards should be lag bolted to the house framing. (see sample)
- Post and concrete footings at the front deck are misaligned but should not be a structural concern.

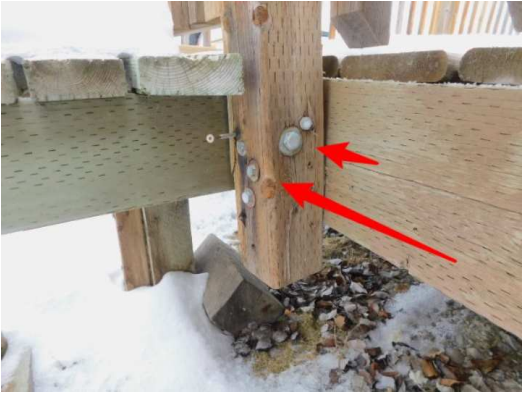
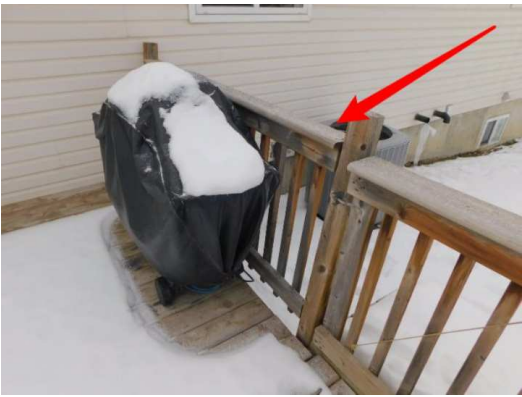
REP 33: The railings at the back deck are not sturdy enough to resist a person's weight. One post is loose. We recommend that the railings be reinforced or replaced in accordance with present standards.

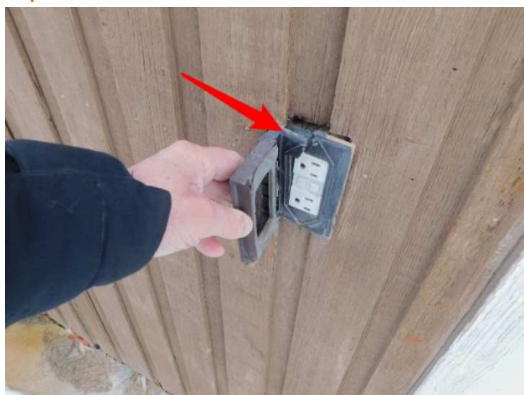
REP 35: The exterior receptacles were found to be in serviceable condition and GFCI protected.

- Back outlet cover by patio door is damaged and should be replaced and properly sealed to the siding at the top and sides.

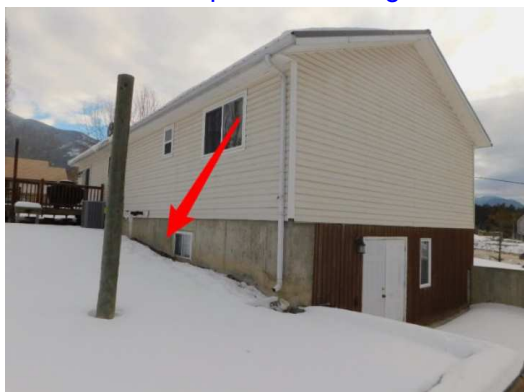
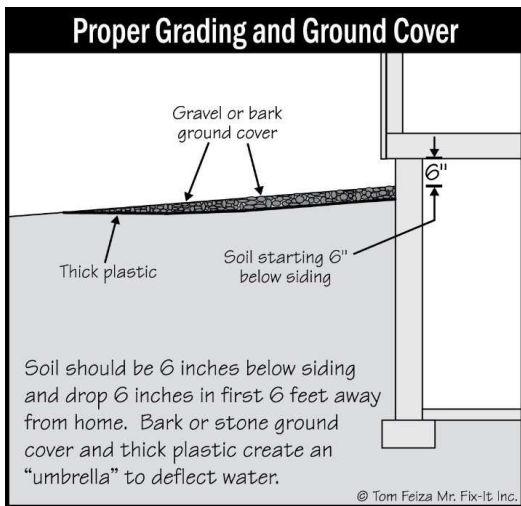
UPG 39: The soil at the back and side is flat, recommend it be re graded to slope 6" for every 6' away from the house for improved drainage of water away from the foundation.

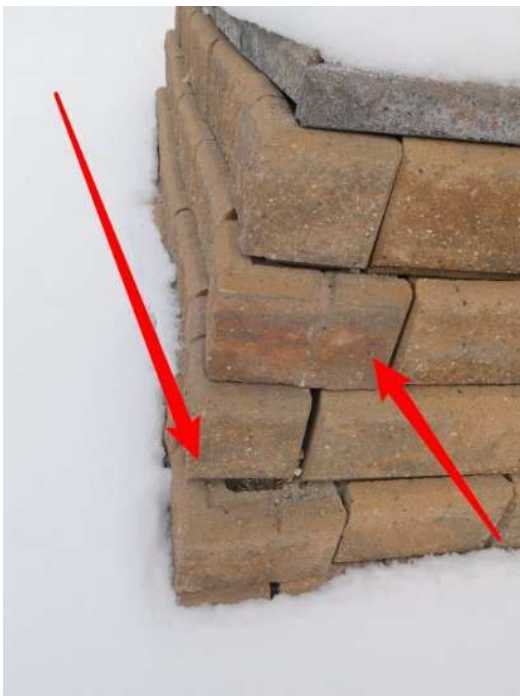
MON 40: The structural retaining walls appear to have performed as intended and are generally in serviceable condition, with reportable conditions noted below.

- Small displacement of some of the blocks.

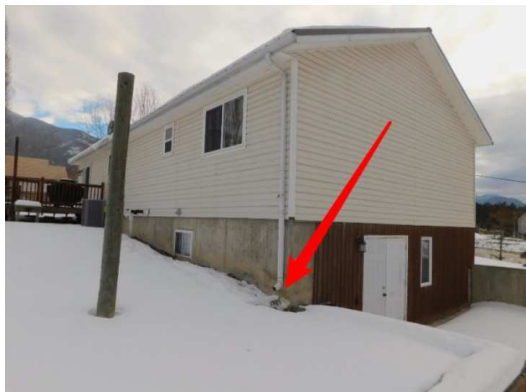
53: The downspouts appear to be properly installed and in serviceable condition, with exceptions noted below.

- Leader disconnected at the west corner.

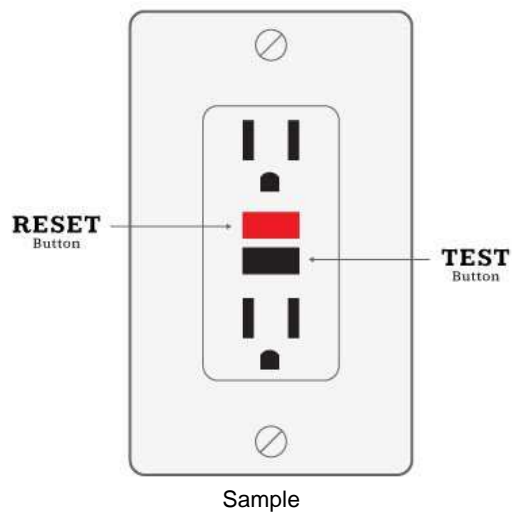
SAFT **UPG** **92:** There is no GFCI (ground fault circuit interrupter) protection for the countertop receptacle(s) within six feet of the sink. For an increased margin of safety, we recommend the installation of a GFCI receptacle(s).

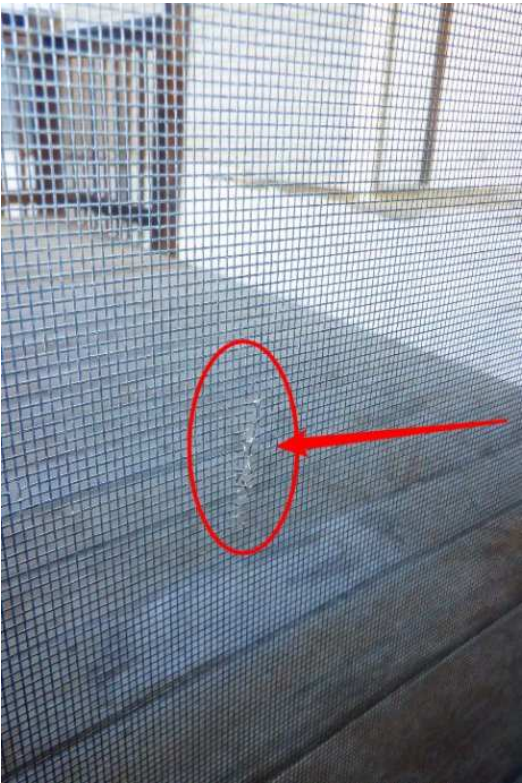
REP 121: Caulking around the door frame is cracked and coming off. Recommend recaulking. Screen lightly damaged.

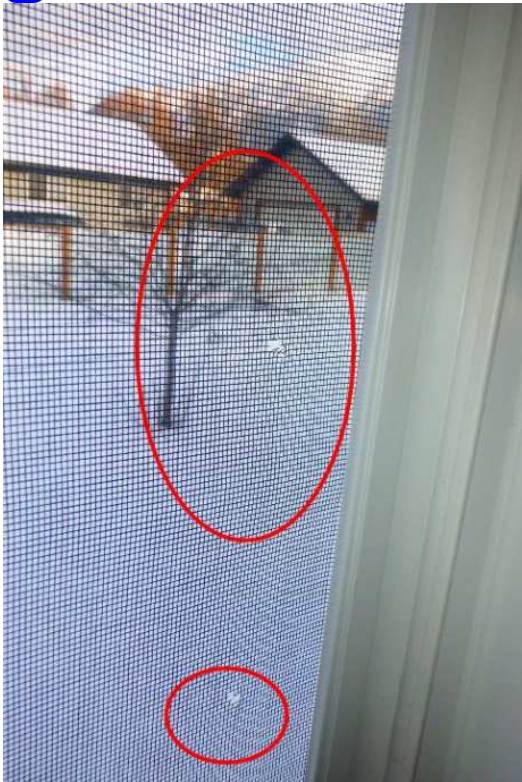
UPG 147: Light screen damaged.

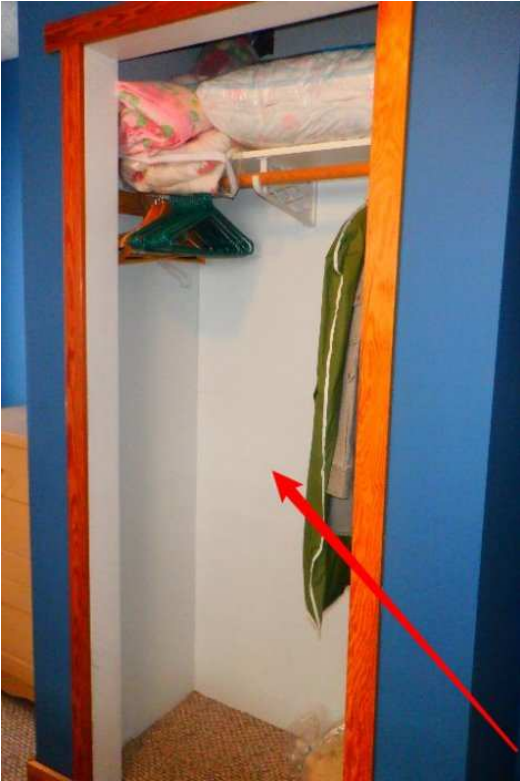
UPG 150: Door missing.

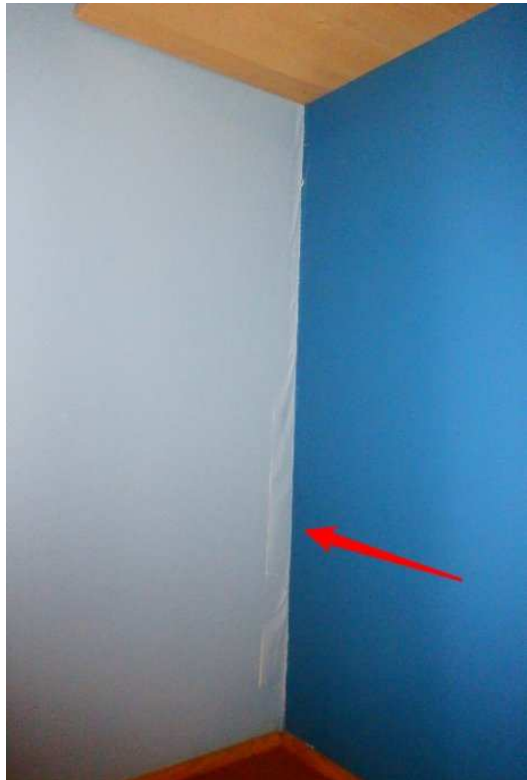
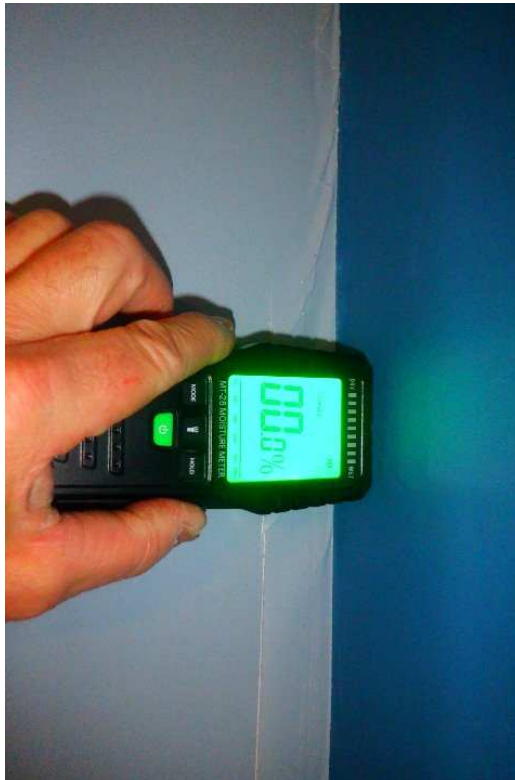
REP 153: The tape on some of the drywall joints has separated. We recommend resurfacing and refinishing to restore appearance.

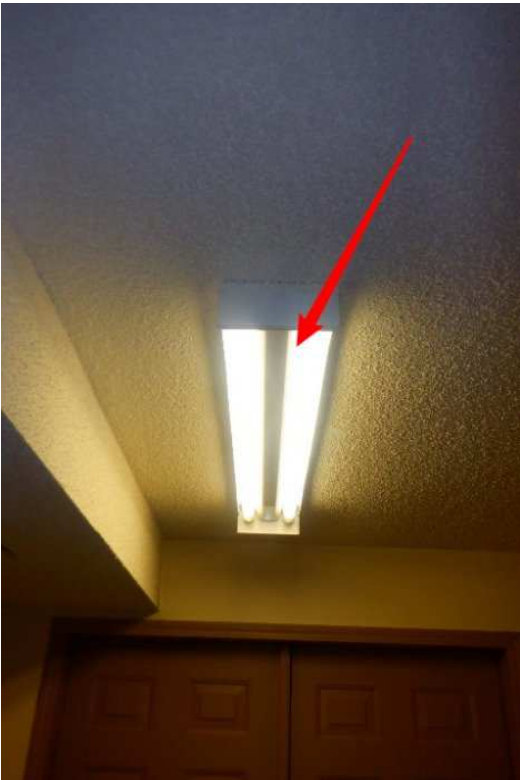
UPG 227: The fixture is missing it's cover. We recommend the fixture cover be installed for better lighting in this area.

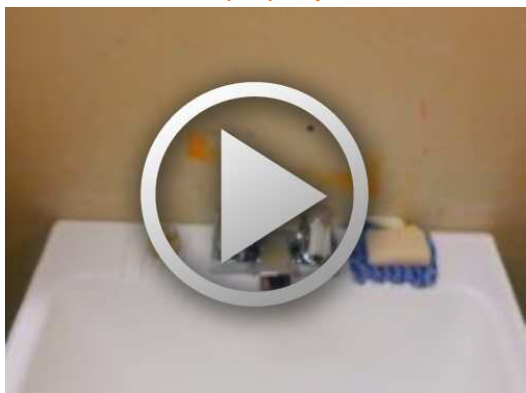
REP 237: The laundry tub is free standing and not secured to either the floor or the wall behind. We recommend it be properly secured.

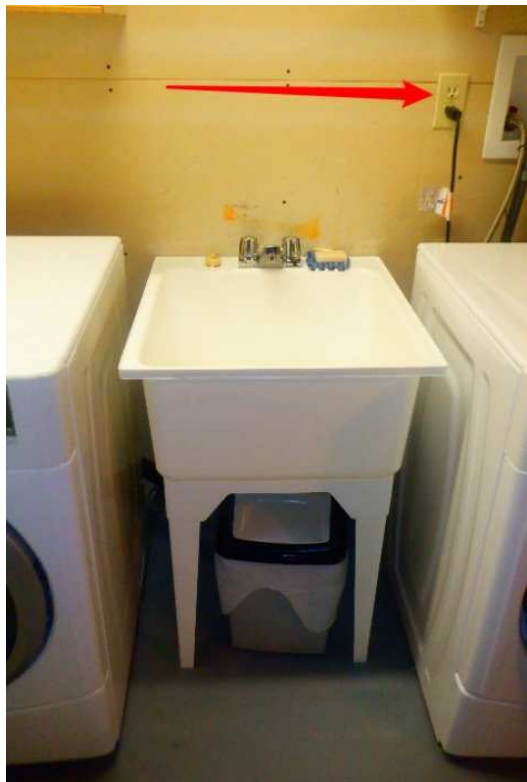
SAFT 238: There is no GFCI (ground fault circuit interrupter) protection for this area. For an increased margin of safety, we recommend the installation of a GFCI receptacle.

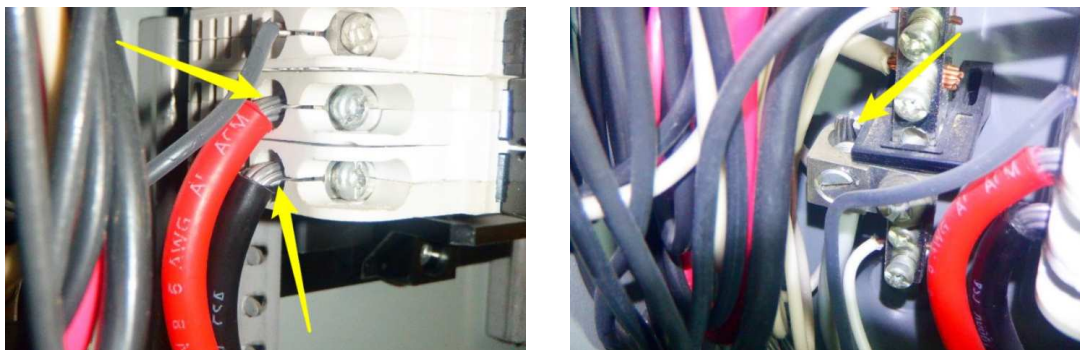
UPG 276: The accessible aluminum connections are installed in accordance with standard trade practice, but lack the application of an anti-oxidant. As preventive maintenance, we recommend that each accessible connection be covered with an anti-oxidant.

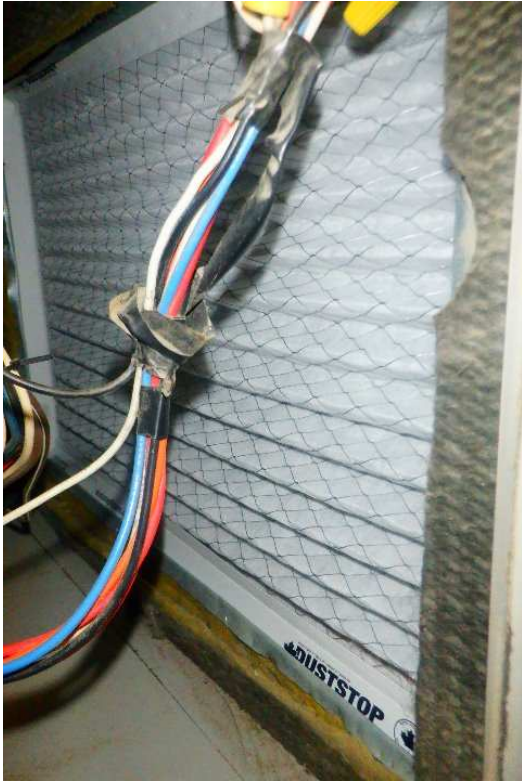
330: The filter has accumulated debris which decreases its effectiveness and blocks air flow. We recommend the filter be replaced every 3-6 months.

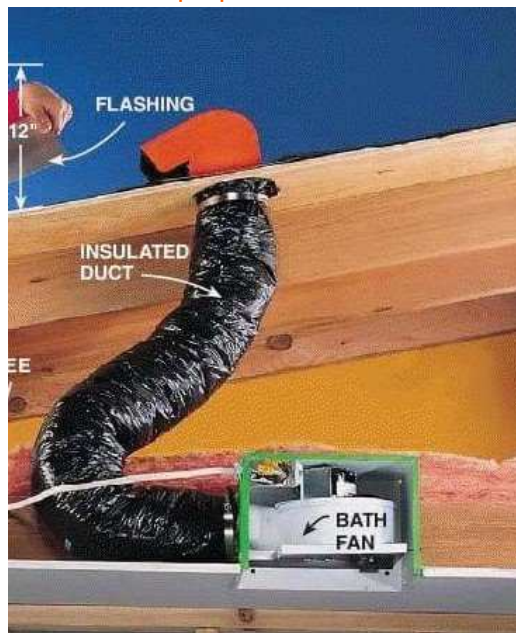
UPG 381: Ducts are vented into the soffits which is causing some moisture to back draft into the attic. Recommend vent lines be directed through the roof into a proper roof hood.
