Confidential Inspection Report

LOCATED AT:
Nowhere Rd.
Somewhere, BC

INSPECTED ON:
15 February, 2023

Inspector, Denis Lacroix 71731
Lacroix Home Inspection

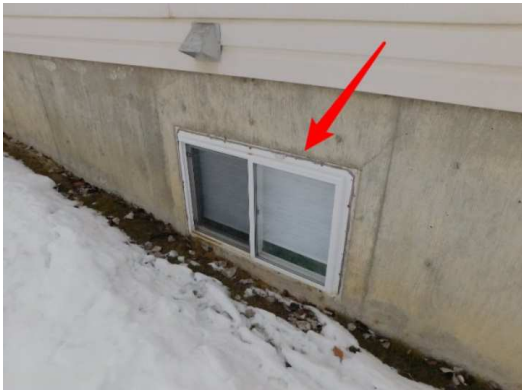
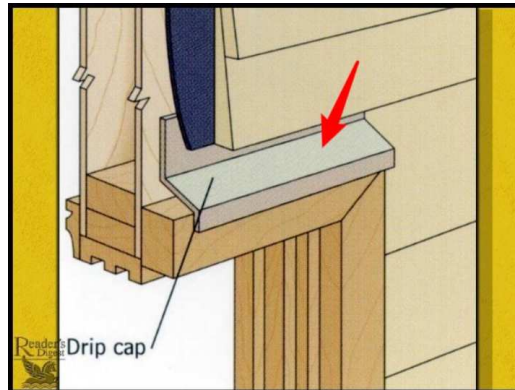
REP s-25: No flashing has been installed at the back basement window, as would be considered standard practice. We recommend an acceptable metal flashing be installed to prevent leakage.

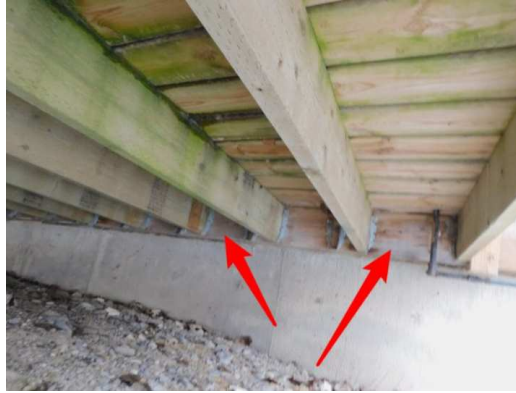
Front deck

- Ledger boards should be lag bolted to the house framing. (see sample)
- Post and concrete footings at the front deck are misaligned but should not be a structural concern.

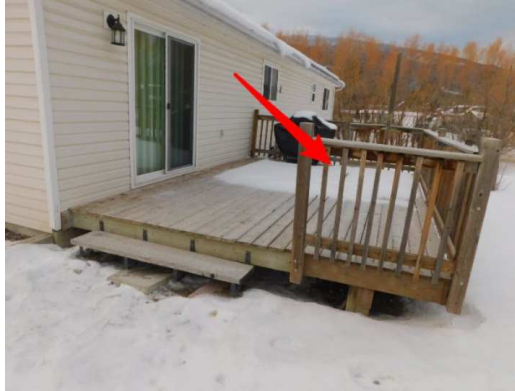
REP s-33: The railings at the back deck are not sturdy enough to resist a person's weight. One post is loose. We recommend that the railings be reinforced or replaced in accordance with present standards.

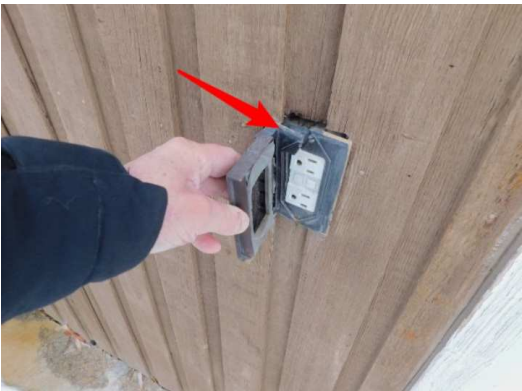
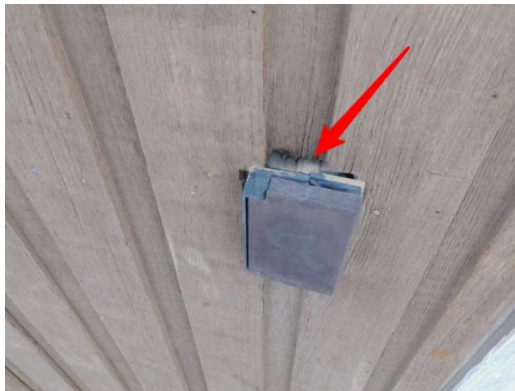
- Back outlet cover by patio door is damaged and should be replaced and properly sealed to the siding at the top and sides.

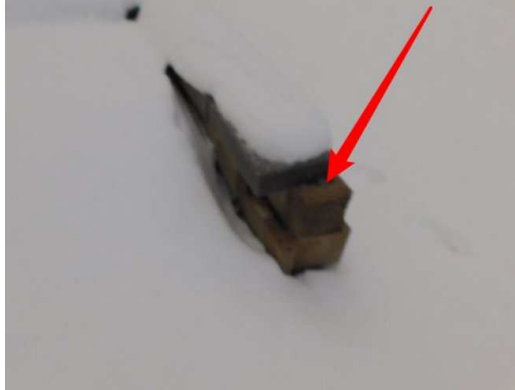
MON s-40: The structural retaining walls appear to have performed as intended and are generally in serviceable condition, with reportable conditions noted below.

- Small displacement of some of the blocks.

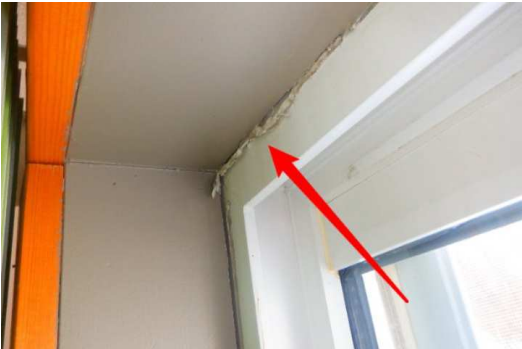
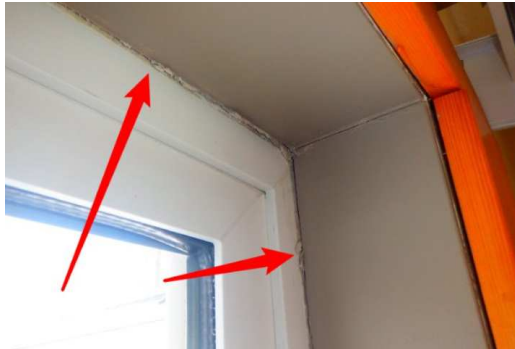
REP s-121: Caulking around the door frame is cracked and coming off. Recommend recaulking. Screen lightly damaged.

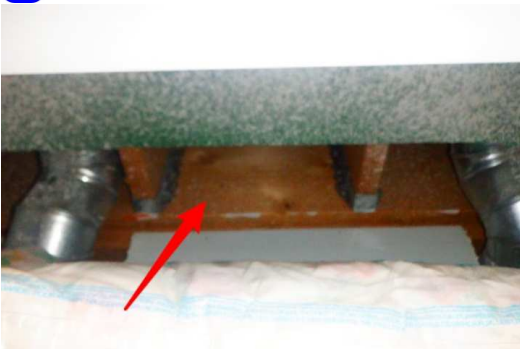
UPG s-154: Unfinished inside the closet.

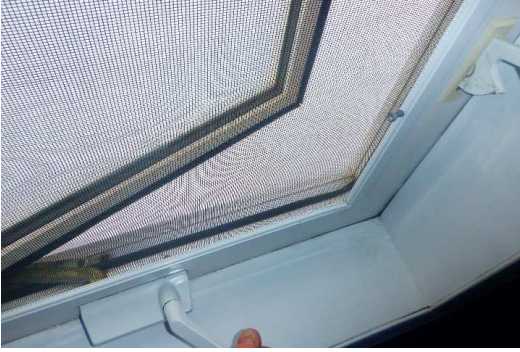
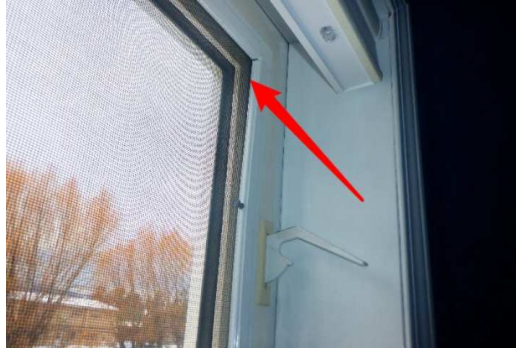
REP s-158: Window does not close properly. Top of window had to be pushed in from the outside. Recommend adjusting.

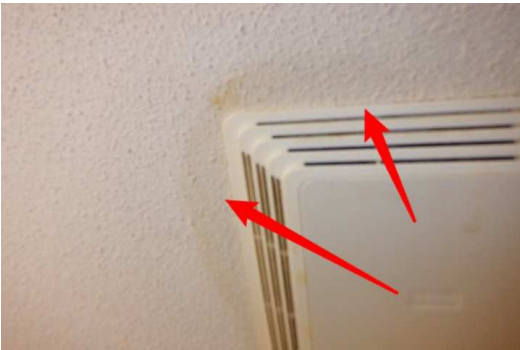
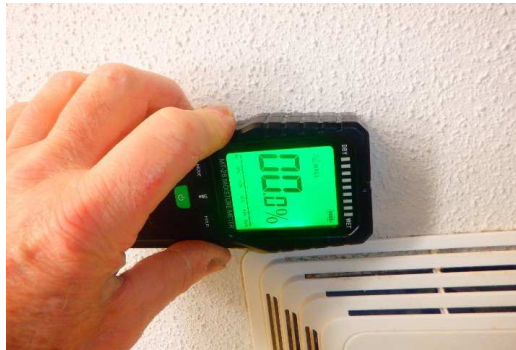
MON s-167: The ceiling is water stained around the fan, however, no evidence of moisture or leakage was observed. This may be due to snow melting around the exhaust hood and entering the vent on the roof in the spring. The stained area should be monitored and, in the event of future leakage, the source should be identified and repaired.

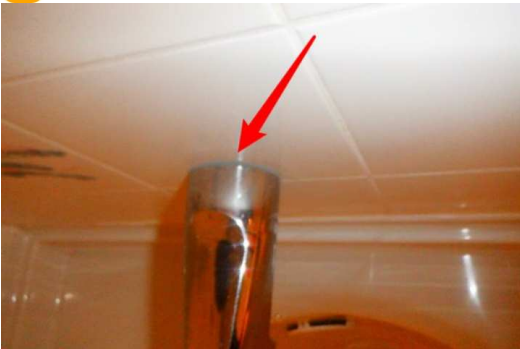
REP s-216: Recommend adding caulk to the spout to wall joint to prevent water intrusion.

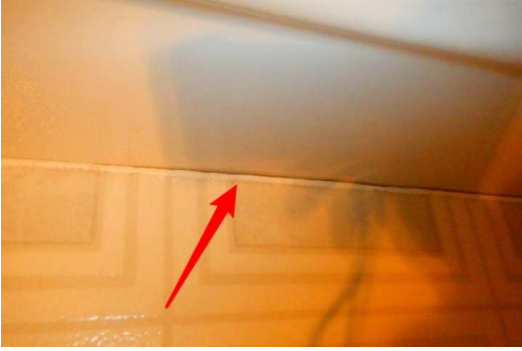
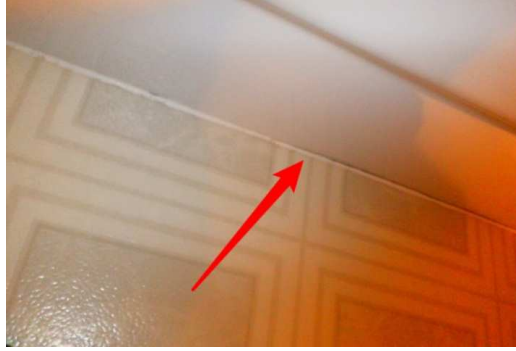
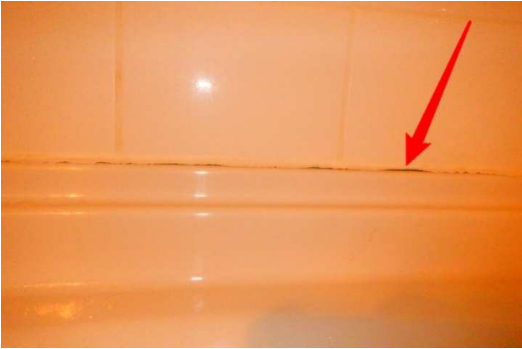
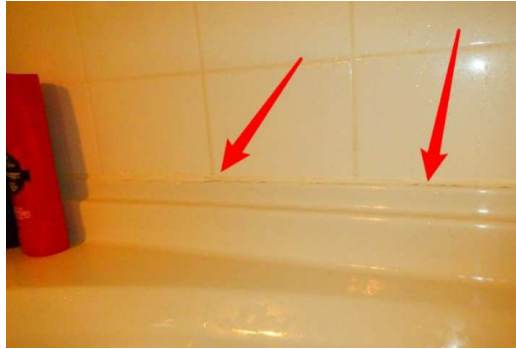
REP s-217: The caulking between the bathtub and the floor and surround is cracked/damaged and should be redone.

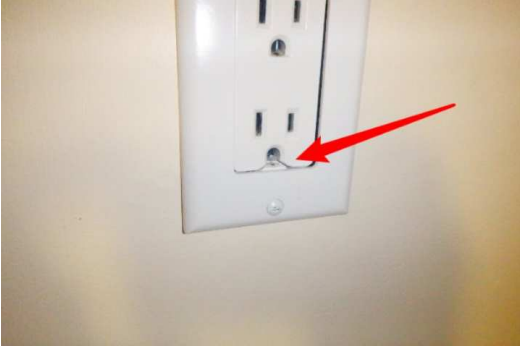
UPG **s-251:** A receptacle at the left of the entrance is damaged. We recommend it be replaced.

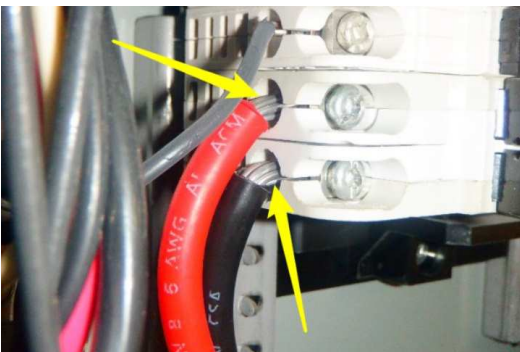
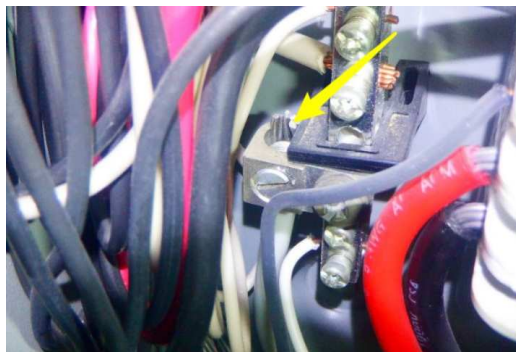
UPG **s-276:** The accessible aluminum connections are installed in accordance with standard trade practice, but lack the application of an anti-oxidant. As preventive maintenance, we recommend that each accessible connection be covered with an anti-oxidant.

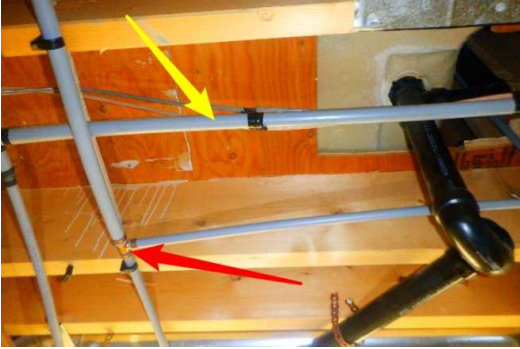
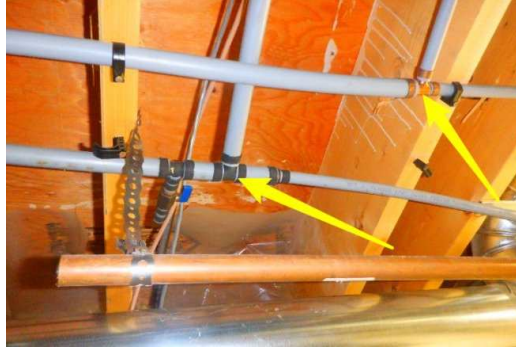
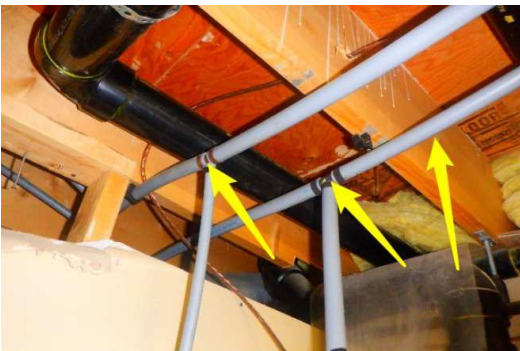
WARN MON s-288: Poly B was used between the years 1983 and 1995. Poly was recalled due to leakage issues. Issues included; plastic fittings used cracked under pressure from the crimps, heat caused degradation of the pipes, excessive chlorine in the water also damaged the pipe material.

In this house all connectors were copper.
There was no heavy smell of chlorine in the water and all pipes appeared to not be in contact with any heat source.

Recommend checking with insurance company regarding policy on Poly B.

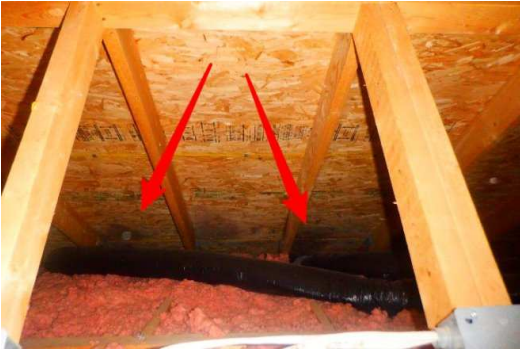
UPG s-381: Ducts are vented into the soffits which is causing some moisture to back draft into the attic. Recommend vent lines be directed through the roof into a proper roof hood.

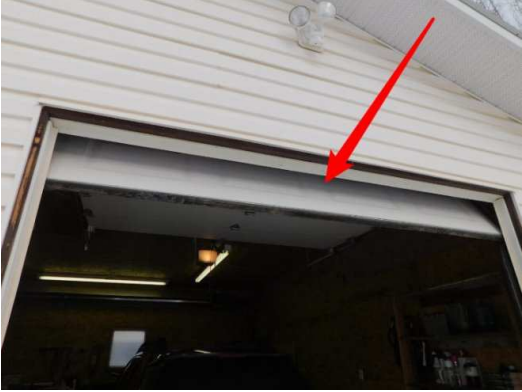
REP s-394: Doesn't appear to open the door all the way.

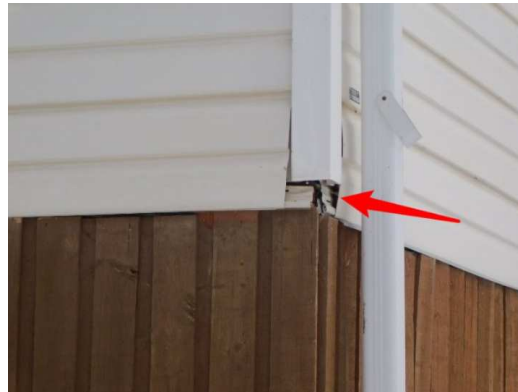
UPG 21: The vinyl siding appears to be properly installed and generally in serviceable condition, with exceptions noted below.

- A few small damaged areas were noted. Areas should be repaired to prevent water intrusion.

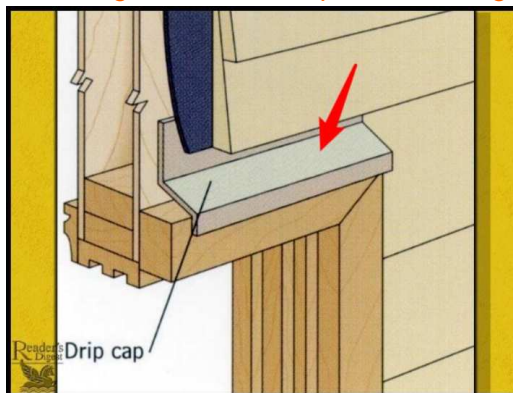
REP 25: No flashing has been installed at the back basement window, as would be considered standard practice. We recommend an acceptable metal flashing be installed to prevent leakage.

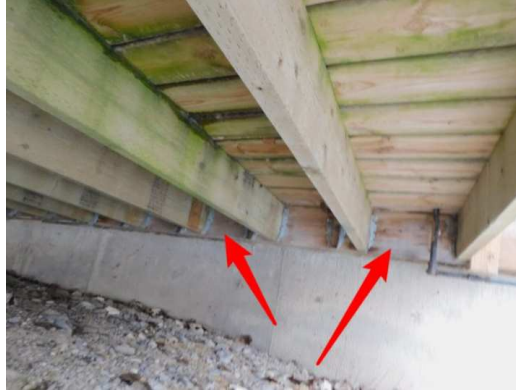
Front deck

REP 32: The decks appear to be properly constructed and generally in serviceable condition, with exceptions noted below.

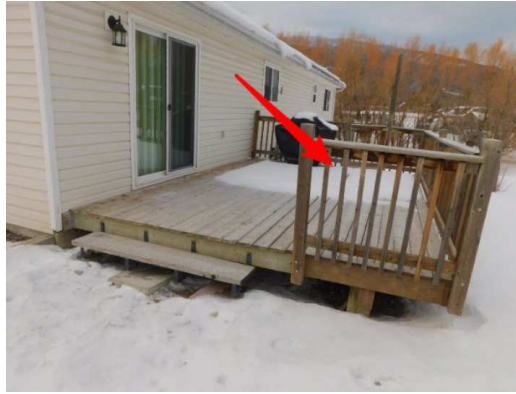
REP 33: The railings at the back deck are not sturdy enough to resist a person's weight. One post is loose. We recommend that the railings be reinforced or replaced in accordance with present standards.

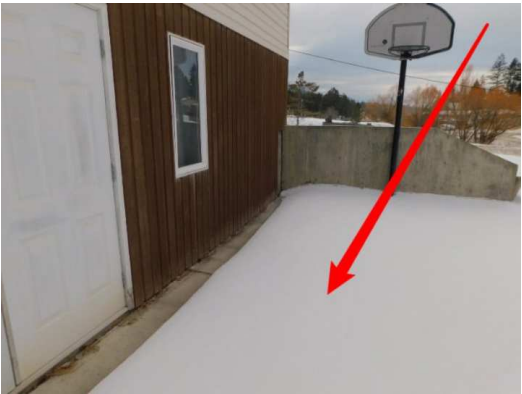
34: The patio appears to be installed in a professional manner and is in good condition. **Patio was not fully inspected due to snow coverage.**

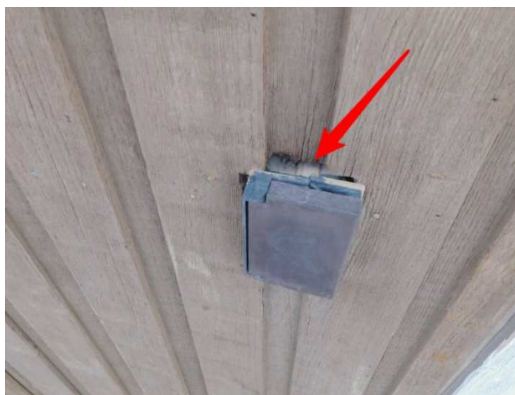
- Back outlet cover by patio door is damaged and should be replaced and properly sealed to the siding at the top and sides.

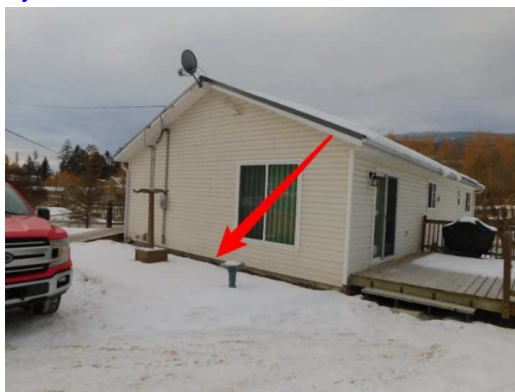
UPG 39: The soil at the back and side is flat, recommend it be re graded to slope 6" for every 6' away from the house for improved drainage of water away from the foundation.

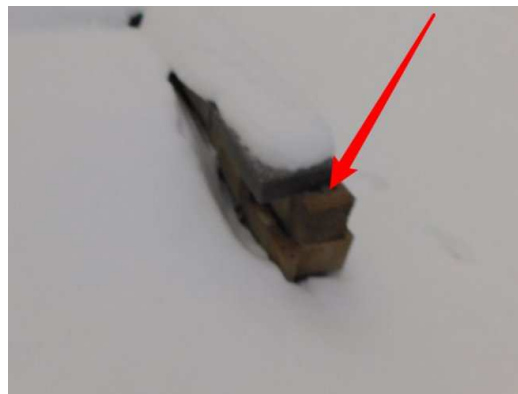
MON 40: The structural retaining walls appear to have performed as intended and are generally in serviceable condition, with reportable conditions noted below.

- Small displacement of some of the blocks.

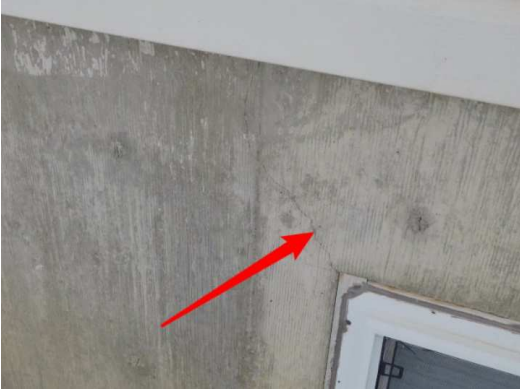
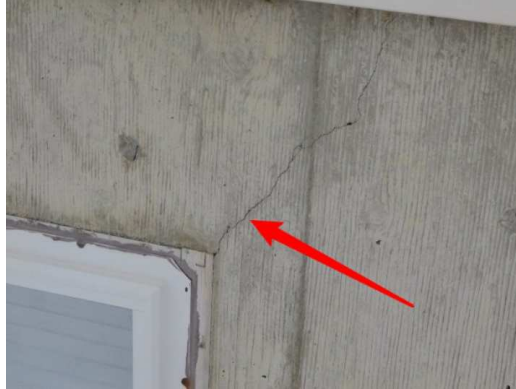
MON 42: Hairline and/or small cracks, within normal tolerances, are visible. This type of cracking is often a result of shrinkage of materials and/or minor settlement and usually does not affect the strength of the foundation. Recommend monitoring over time.

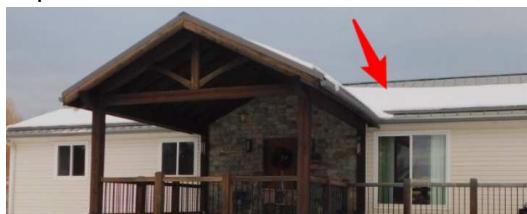
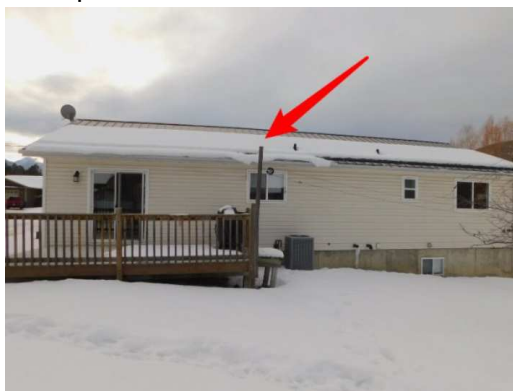
WARN 49: The snow cover on the roof at the time of this inspection rendered a physical inspection of the roof impractical. Our comments, therefore, are based upon limited visual observations.

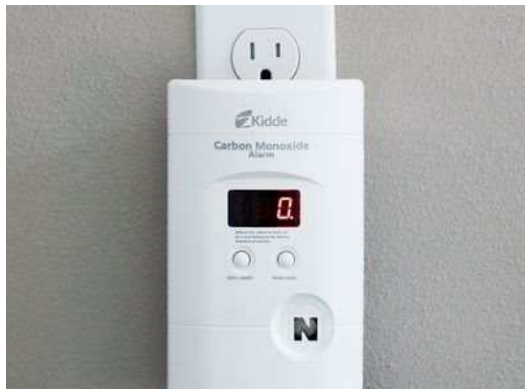
SAFT 67: Although Co monitors may be in combination with ceiling smoke alarm, consider installing Co monitors at an outlet near the floor on all floors when a wood or gas appliance is present in the home as an added

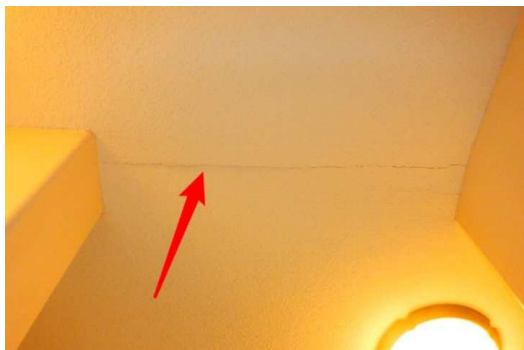
UPG MON 74: There are minor ceiling cracks. This type of cracking in this material is common and does not indicate a structural deficiency. These can be patched, prepared and finished in the course of routine maintenance.

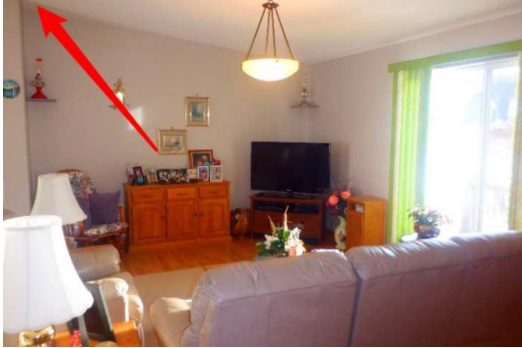
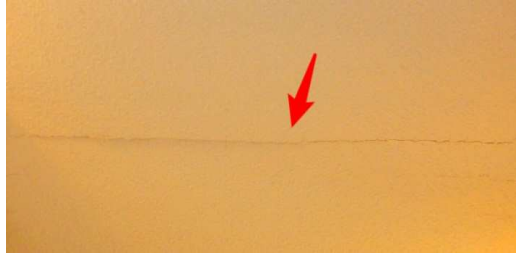
MON 106: There are minor ceiling cracks. This type of cracking in this material is common and does not indicate a structural deficiency. These can be patched, prepared and finished in the course of routine maintenance.

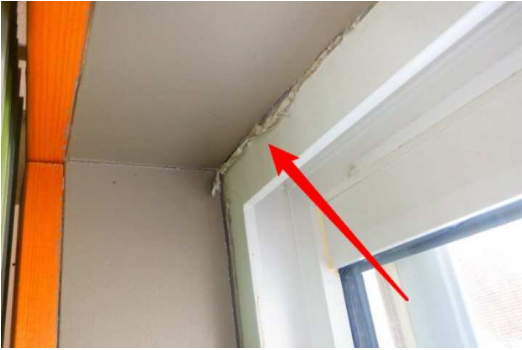
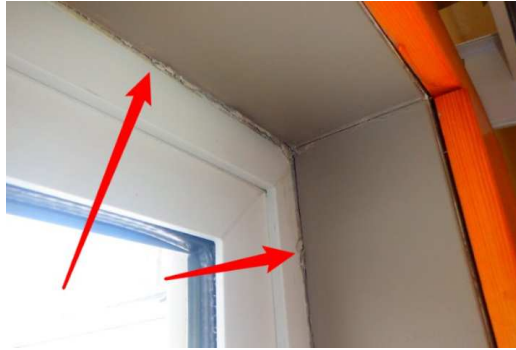
REP 121: Caulking around the door frame is cracked and coming off. Recommend recaulking. Screen lightly damaged.

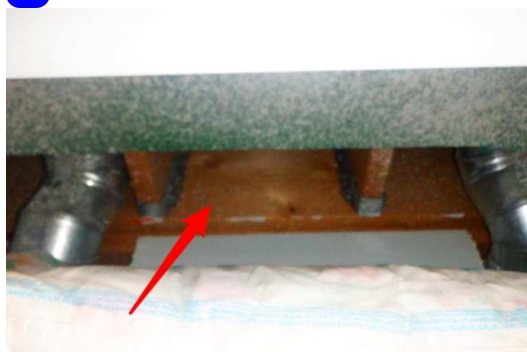
UPG 154: Unfinished inside the closet.

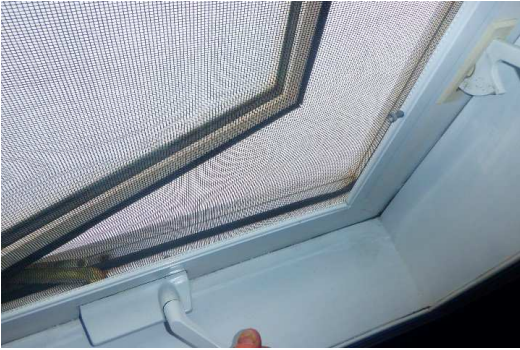
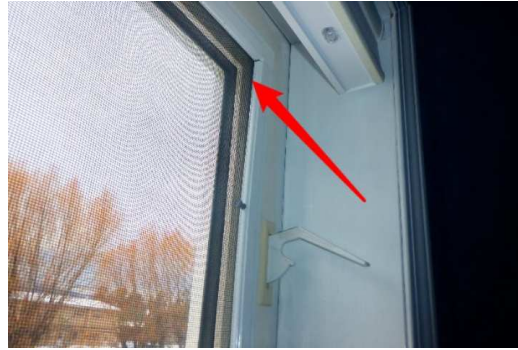
REP 158: Window does not close properly. Top of window had to be pushed in from the outside. Recommend adjusting.

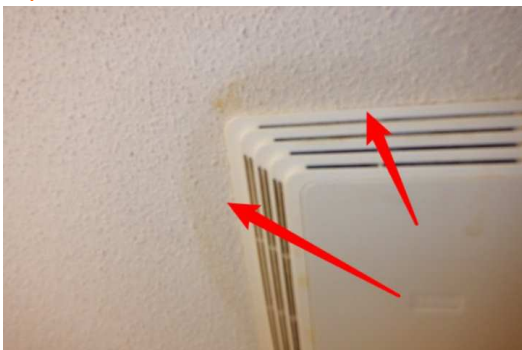
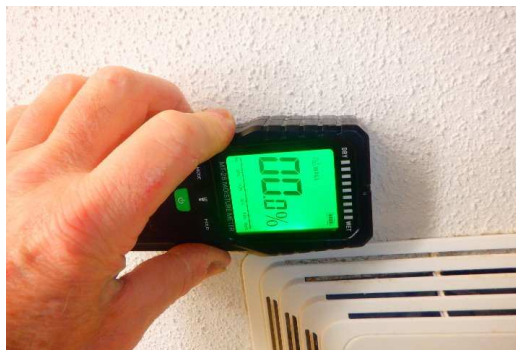
MON 167: The ceiling is water stained around the fan, however, no evidence of moisture or leakage was observed. This may be due to snow melting around the exhaust hood and entering the vent on the roof in the spring. The stained area should be monitored and, in the event of future leakage, the source should be identified and repaired.

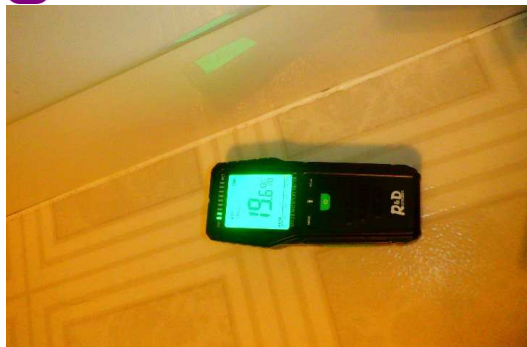
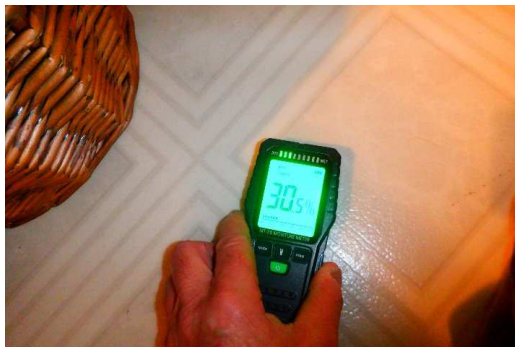
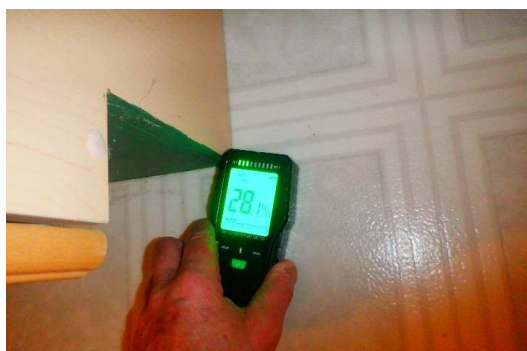
MON 208: Elevated levels of moisture noted, possibly due to linoleum being installed directly on concrete.

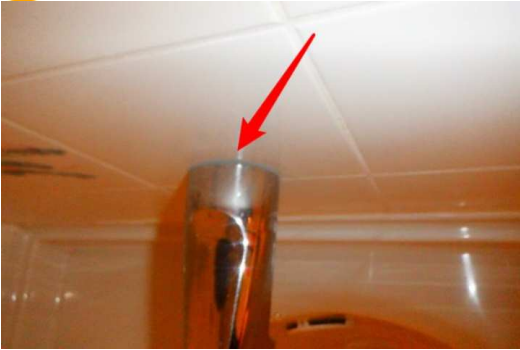
REP 216: Recommend adding caulk to the spout to wall joint to prevent water intrusion.

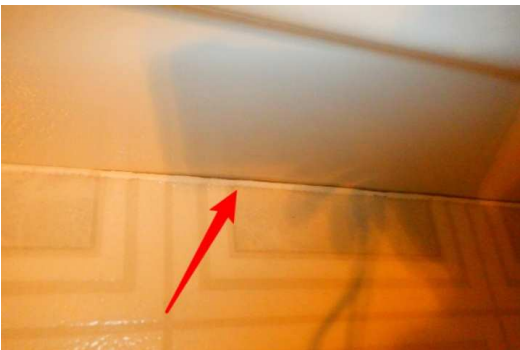
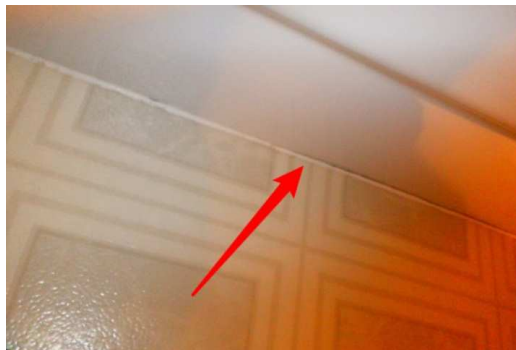
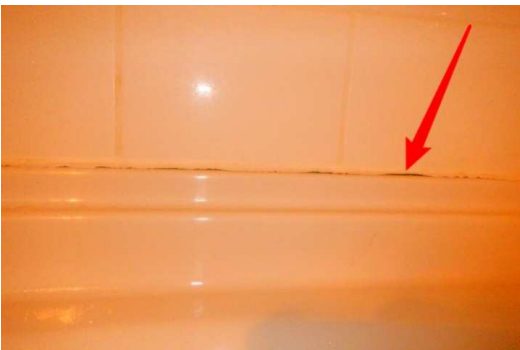
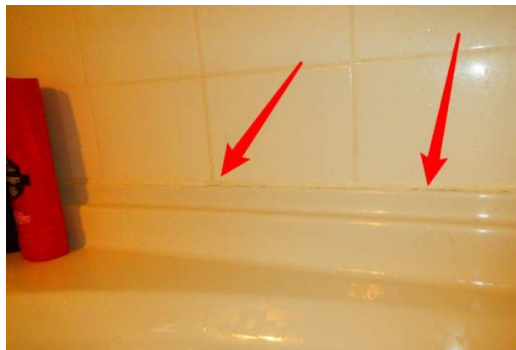
REP 217: The caulking between the bathtub and the floor and surround is cracked/damaged and should be redone.

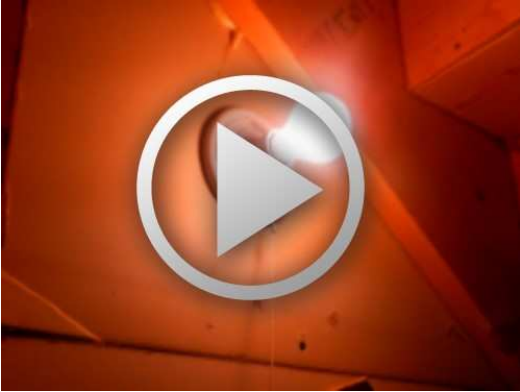
SAFT 228: Light in the storage under the stairs has a short circuit. Recommend a licensed electrician for repair or replacement.

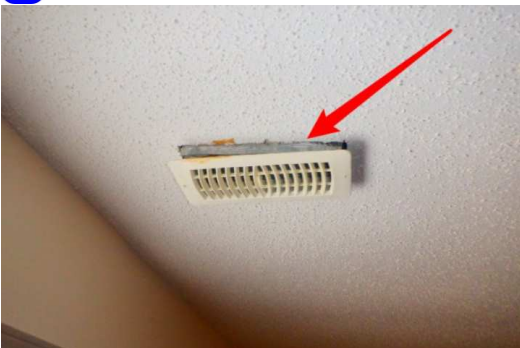
UPG 230: Register coming off the ceiling. Recommend reattaching.

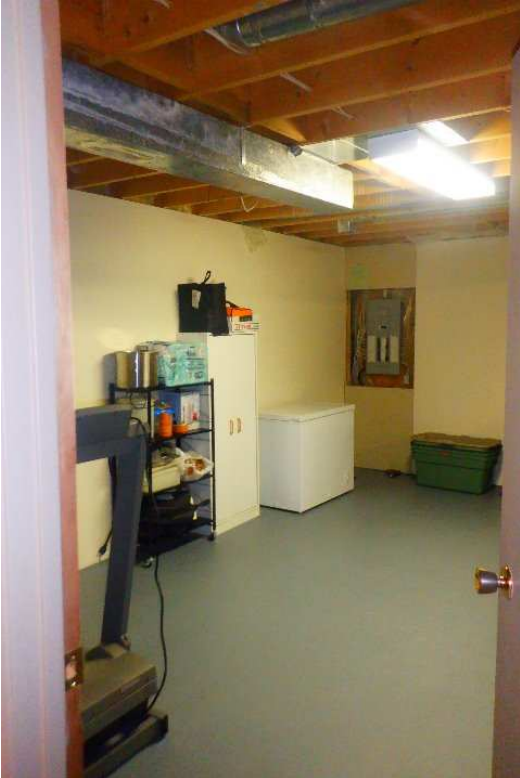
UPG 248: Ceiling is exposed framing.

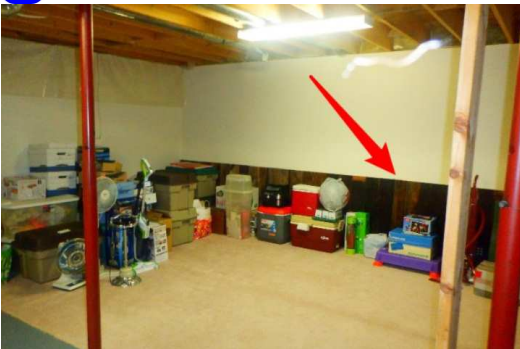
UPG 249: Ceiling is exposed framing.

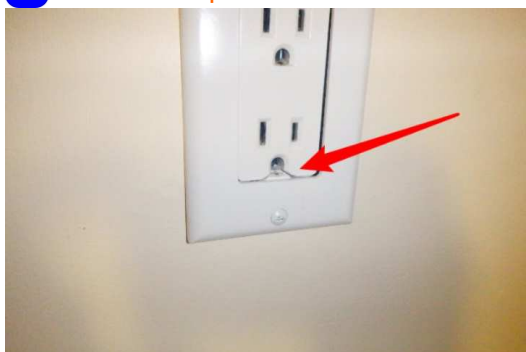
UPG 251: A receptacle at the left of the entrance is damaged. We recommend it be replaced.

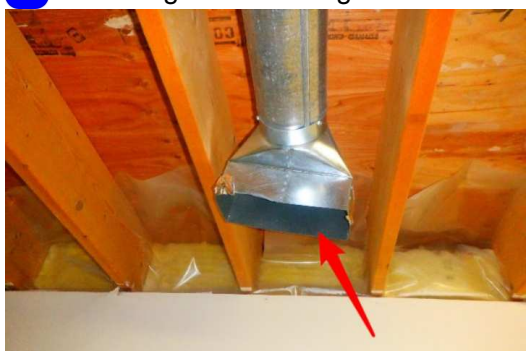
UPG 254: Registers missing.

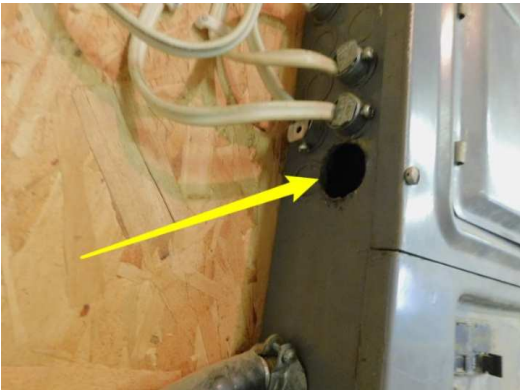
SAFT **REP** **272:** There are holes in the subpanel where 'knockouts' have been removed and left open. These hole may allow access to rodents that may chew the wires that may cause arcing and possible fire. This is not an approved practice and we recommend the holes be closed with approved filler plates.

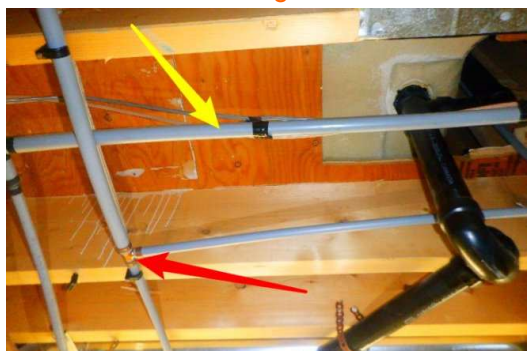
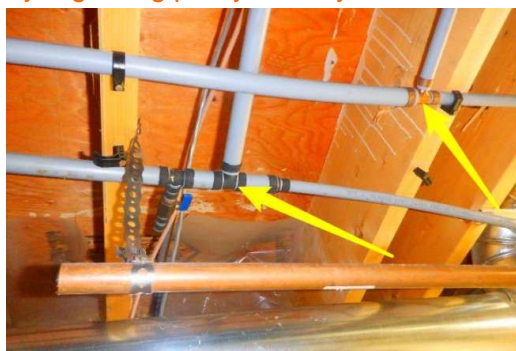
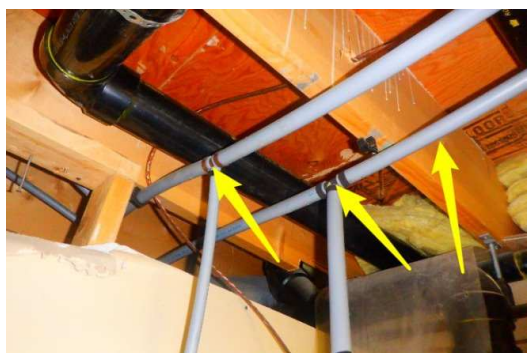
WARN MON 288: Poly B was used between the years 1983 and 1995. Poly was recalled due to leakage issues. Issues included; plastic fittings used cracked under pressure from the crimps, heat caused degradation of the pipes, excessive chlorine in the water also damaged the pipe material.

In this house all connectors were copper.
There was no heavy smell of chlorine in the water and all pipes appeared to not be in contact with any heat source.

Recommend checking with insurance company regarding policy on Poly B.

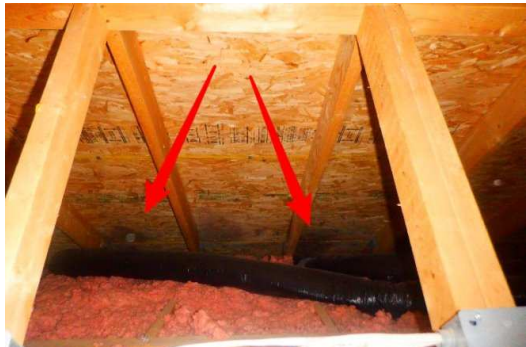
UPG 381: Ducts are vented into the soffits which is causing some moisture to back draft into the attic. Recommend vent lines be directed through the roof into a proper roof hood.

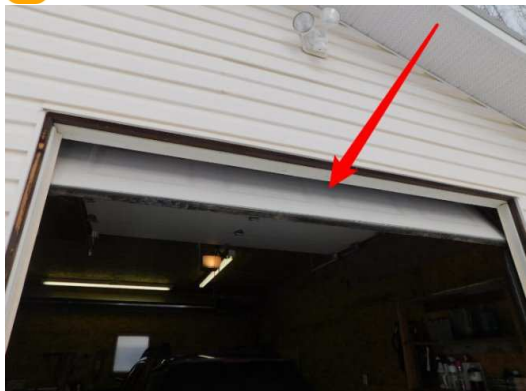
REP 394: Doesn't appear to open the door all the way.
